BMW Car Club
of America
Genesee Valley Chapter

HPDE Technical Inspection Form

Technical Note: BMW Power Steering Line Failures

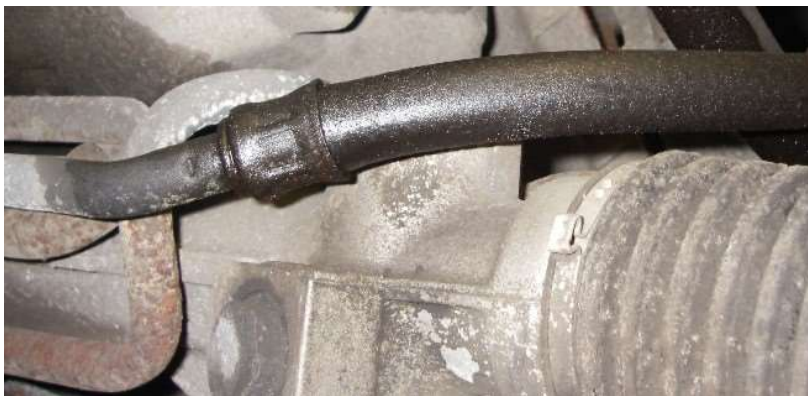
You should also seriously consider replacing the power-steering-return hose with a suitable piece of hose a few centimeters longer. BMW hose # 32-41-1-131-524 [12-mm ID (inside diameter), cut to length] is known to work in this application. You will also need two hose clamps # 11-15-1-727-509 [15-18-mm]. Some claim success with aftermarket high-temperature hose of ½-inch ID, but be advised that the BMW hose fits the nipple on the steering-cooler more tightly than do some nominal ½-inch ID hoses. In the photo, the ferrule is where the failure occurs.

Recently we have seen a number of on-track failures of the power-steering-return hose on E36 (92-99) and E46 (99-06) 3-Series BMWs. The failures we have seen were all the same: the return hose pulled off of the power-steering rack cooler, right at the factory-crimped connection. This failure results in the fluid content of the power-steering system being disgorged in a few seconds, creating a very serious hazard on the track surface for the afflicted car and following vehicles. Of course, steering power-assist is lost as well. Please note that we have seen replacement OE hose assemblies also fail on their first track session, so replacing the power-steering cooler/return-hose assembly with stock parts has been shown to be ineffective in addressing the problem.

Although there is not complete consensus within the BMW-repair community as to the cause of these failures, many feel that the primary problem is that the return hose should be longer, and that engine movement [probably most severe in the on-track environment] exacerbates the problem. Deteriorated engine and/or transmission mounts can allow increased engine movement, and some feel that high temperatures may be an extenuating factor.

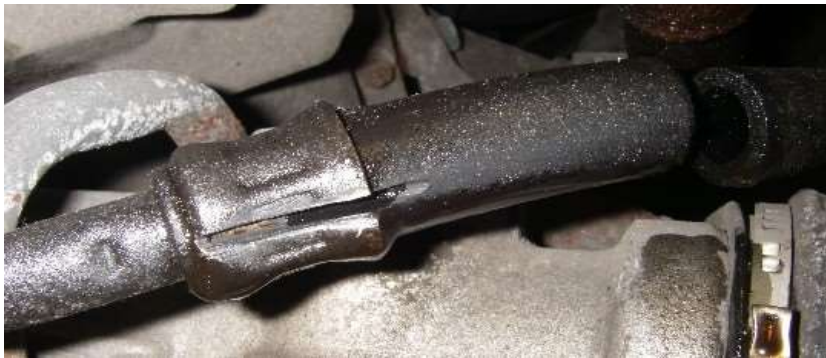
Replacing the return hose is a straightforward operation. After the car has been secured on jack stands or a lift and allowed to cool, begin by cutting the return hose and allowing the contents of the system to drain into a pan. Note that the return hose is the SMALLER of the two hoses attached to the power-steering-fluid reservoir. Then, CAREFULLY slit [as shown in the photo] and remove the ferrule/hose from the power-steering-cooler outlet. An abrasive wheel was used for the photo, but a cutting pliers will suffice. Ensure that the hose nipple under the ferrule is not damaged by the slitting operation. If it is damaged, you will need to procure a new cooler-return- hose assembly.

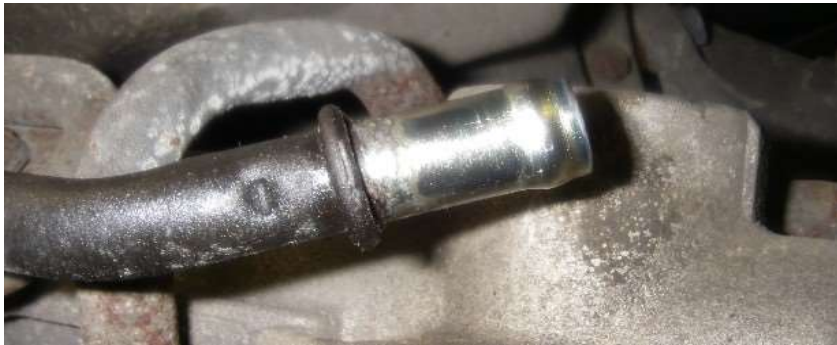
When the ferrule and hose have been removed from the cooler outlet, you should see a hose nipple like this:

Continue by removing the other end of the return hose from the power-steering-fluid reservoir, then cut the new hose to the appropriate length and install to the cooler and reservoir with two hose clamps. You may find that your removed hose contains a restriction orifice located about 10-cm from the reservoir. You can remove this orifice and push it into your new hose, securing the orifice with a third hose clamp. Refill the system with fresh Dexron ATF or other suitable fluid and bleed the system. Check for leaks and you should be done.
