BMW Car Club  
of America  
Genesee Valley Chapter

## GVC Ultimate Driver's School

# Pre-Event Technical Inspection Form

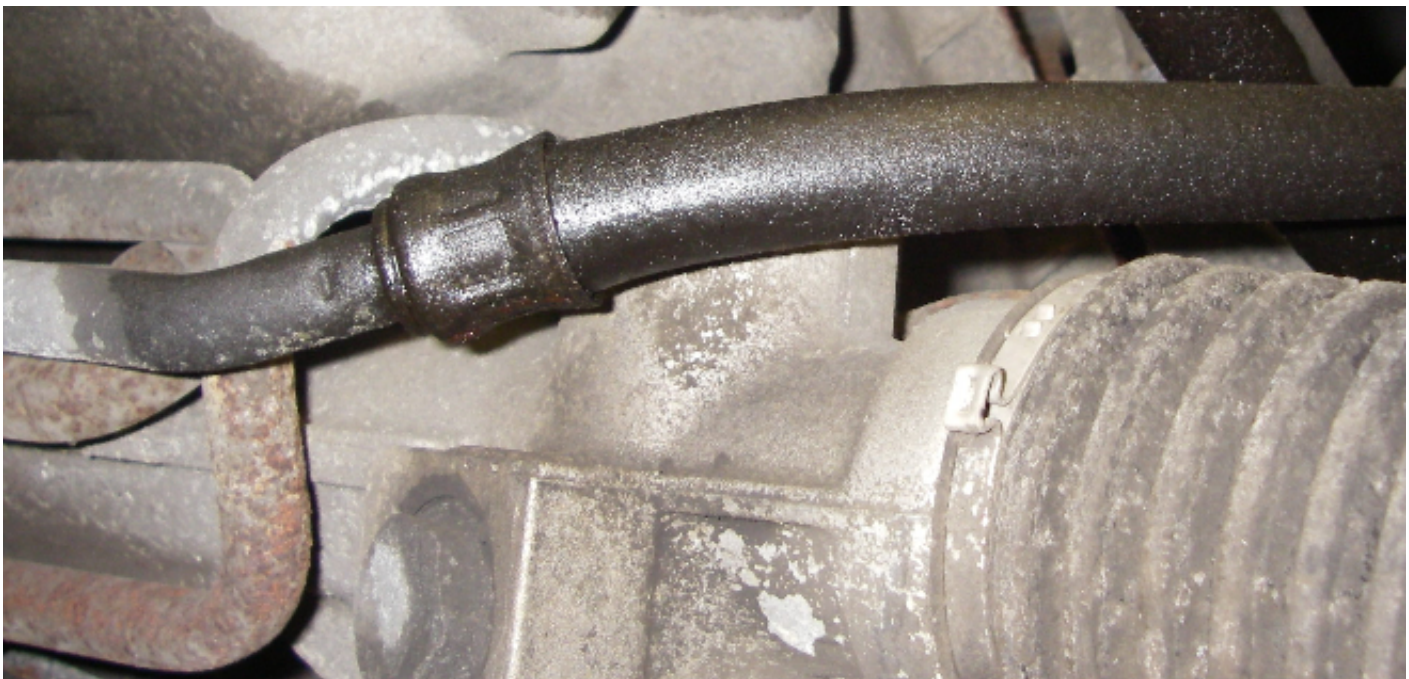
You should also seriously consider replacing the power-steering-return hose with a suitable piece of hose a few centimeters longer. BMW hose # 32-41-1-131-524 [12-mm ID (inside diameter), cut to length] is known to work in this application. You will also need two hose clamps # 11-15-1-727-509 [15-18-mm]. Some claim success with aftermarket high-temperature hose of ½-inch ID, but be advised that the BMW hose fits the nipple on the steering-cooler more tightly than do some nominal ½-inch ID hoses. In the photo, the ferrule is where the failure occurs.

Over the past couple driving seasons, we have seen a number of on-track failures of the power-steering-return hose on E36s [92-99 3-Series, including M3]. The failures we have seen were all the same: the return hose pulled off of the power-steering cooler, right at the factory-crimped connection. This failure results in the fluid content of the power-steering system being disgorged in a few seconds, creating quite a hazard on the track surface for the afflicted car and following vehicles. Of course, steering power-assist is lost as well. Why these failures did not commence earlier in the E36 life cycle remains somewhat a mystery. Please note that we have seen new, OE hose assemblies fail on their first track session, so replacing the power-steering cooler/return-hose assembly with stock parts has been shown to be ineffective in addressing the problem.

Although there is not complete consensus within the BMW-repair community as to the cause of these failures, many feel that the primary problem is that the return hose should be longer, and that engine movement [probably most severe in the on-track environment] exacerbates the problem. Deteriorated engine and/or transmission mounts can allow increased engine movement, and some feel that high temperatures may be an extenuating factor.

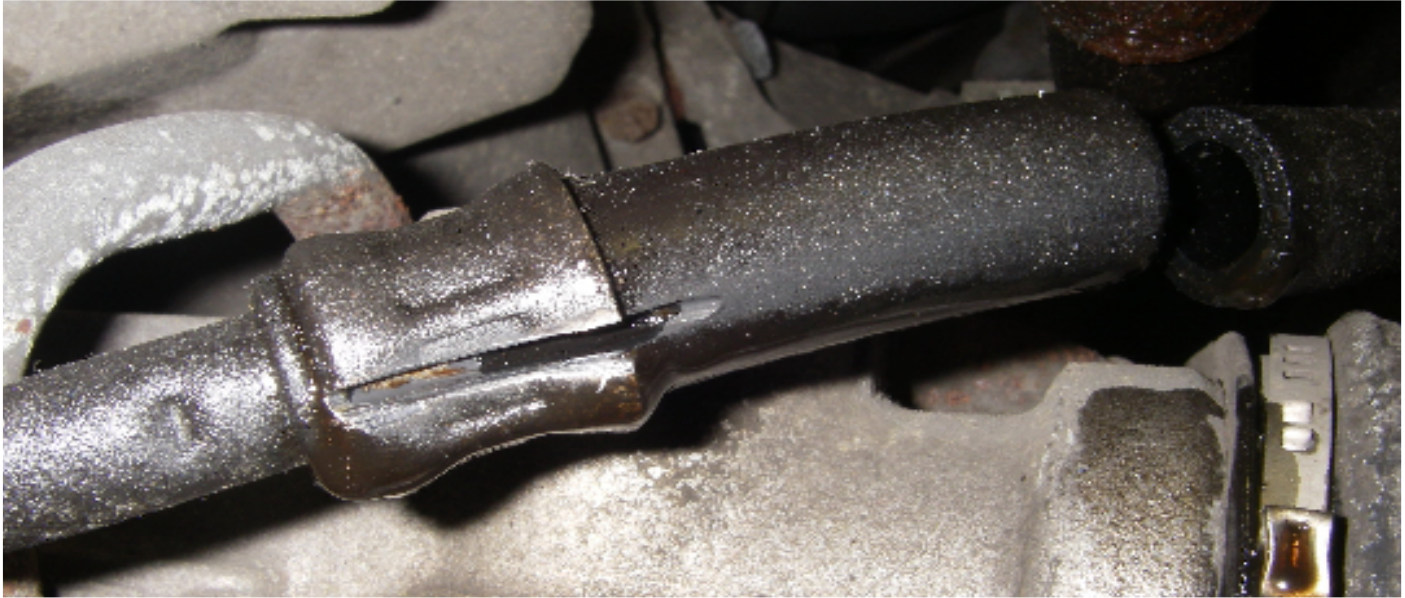
Replacing the return hose is a straightforward operation. After the car has been secured on jack stands or a lift and allowed to cool, begin by cutting the return hose and allowing the contents of the system to drain into a pan. Note that the return hose is the **SMALLER** of the two hoses attached to the power-steering-fluid reservoir. Then, **CAREFULLY** slit [as shown in the photo] and remove the ferrule/hose from the power-steering-cooler outlet. An abrasive wheel was used for the photo, but a cutting pliers will suffice. Ensure that the hose nipple under the ferrule is not damaged by the slitting operation. If it is damaged, you will need to procure a new cooler-return-hose assembly.

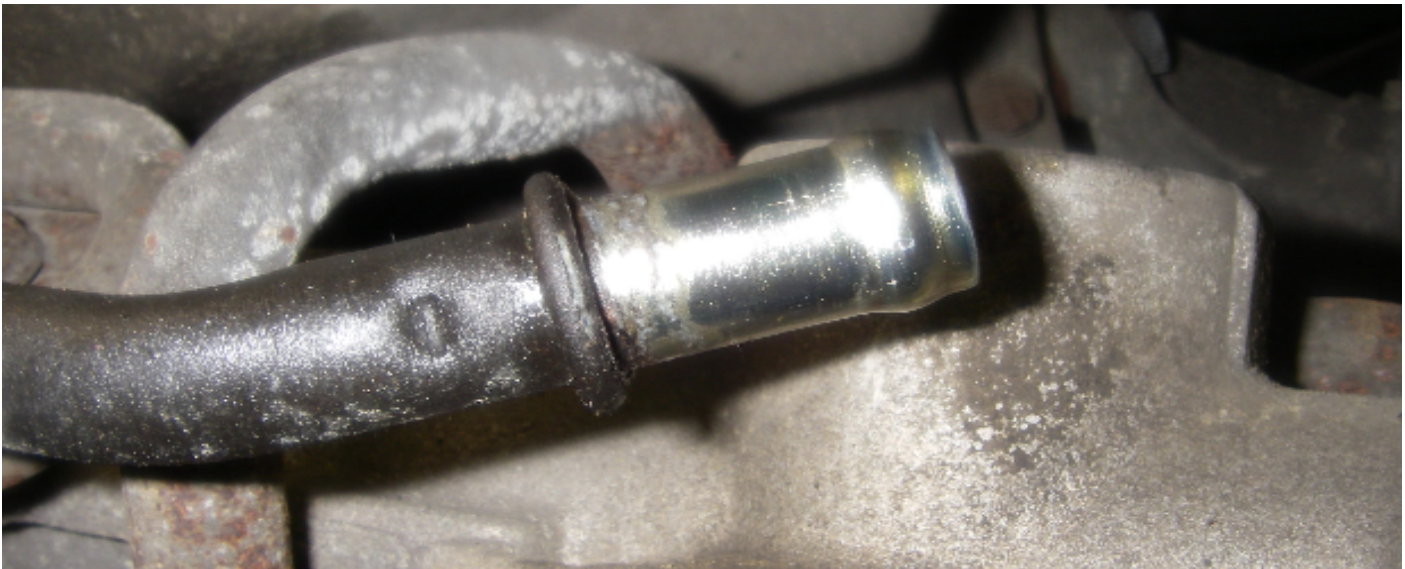
When the ferrule and hose have been removed from the cooler outlet, you should see a hose nipple like this:

Continue by removing the other end of the return hose from the power-steering-fluid reservoir, then cut the new hose to the appropriate length and install to the cooler and reservoir with two hose clamps. You may find that your removed hose contains a restriction orifice located about 10-cm from the reservoir. You can remove this orifice and push it into your new hose, securing the orifice with a third hose clamp. Refill the system with Dexron ATF or other suitable fluid and bleed the system. Check for leaks and you should be done.
