BMW Car Club
of America
Genesee Valley Chapter

HPDE Technical Inspection Form

Technical Note: BMW Power Steering Line Failures

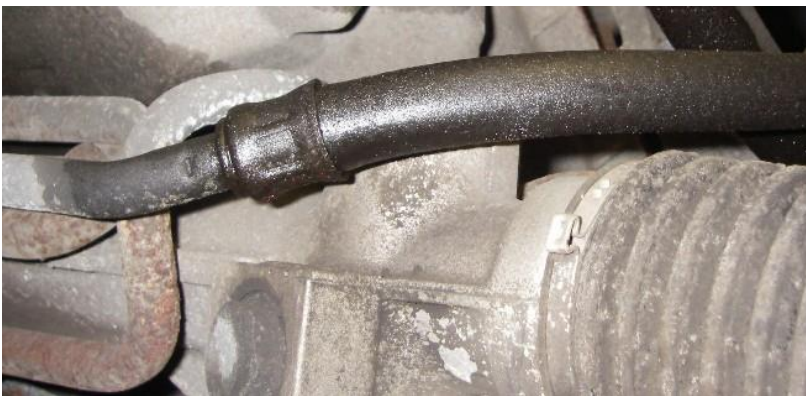
Recently we have seen a number of on-track failures of the power-steering-return hose on E36 (92-99) and E46 (99-06) 3-Series BMWs. The failures we have seen were all the same: the return hose pulled off of the power-steering rack cooler, right at the factory-crimped connection. This failure results in the fluid content of the power-steering system being disgorged in a few seconds, creating a very serious hazard on the track surface for the afflicted car and following vehicles. Of course, steering power-assist is lost as well. Please note that we have seen replacement OE hose assemblies also fail on their first track session, so replacing the power-steering cooler/return-hose assembly with stock parts has been shown to be ineffective in addressing the problem.

You should also seriously consider replacing the power-steering-return hose with a suitable piece of hose a few centimeters longer. BMW hose # 32-41-1-131-524 [12-mm ID (inside diameter), cut to length] is known to work in this application. You will also need two hose clamps # 11-15-1-727-509 [15-18-mm]. Some claim success with aftermarket high-temperature hose of ½-inch ID, but be advised that the BMW hose fits the nipple on the steering-cooler more tightly than do some nominal ½-inch ID hoses. In the photo, the ferrule is where the failure occurs.

Replacing the return hose is a straightforward operation. After the car has been secured on jack stands or a lift and allowed to cool, begin by cutting the return hose and allowing the contents of the system to drain into a pan. Note that the return hose is the SMALLER of the two hoses attached to the power-steering-fluid reservoir. Then, CAREFULLY slit [as shown in the photo] and remove the ferrule/hose from the power-steering-cooler outlet. An abrasive wheel was used for the photo, but a cutting pliers will suffice. Ensure that the hose nipple under the ferrule is not damaged by the slitting operation. If it is damaged, you will need to procure a new cooler-return- hose assembly.

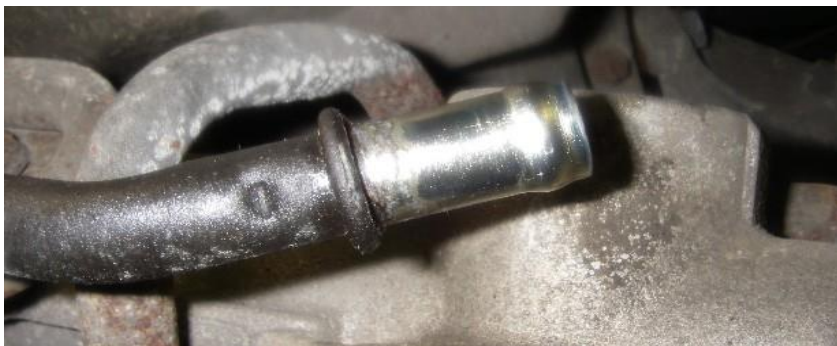
When the ferrule and hose have been removed from the cooler outlet, you should see a hose nipple like this:

Continue by removing the other end of the return hose from the power-steering-fluid reservoir, then cut the new hose to the appropriate length and install to the cooler and reservoir with two hose clamps. You may find that your removed hose contains a restriction orifice located about 10-cm from the reservoir. You can remove this orifice and push it into your new hose, securing the orifice with a third hose clamp. Refill the system with fresh Dexron ATF or other suitable fluid and bleed the system. Check for leaks and you should be done.
